Main Wire Harness Replacement

Model: 5680

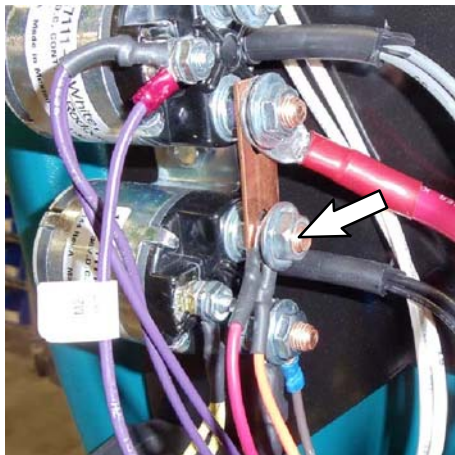
Connect new wire [3D/Orange]
to Main Connector as shown.

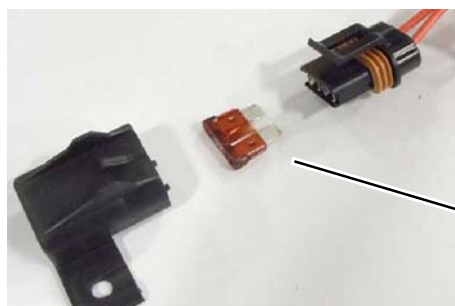
New 7.5 Amp Fuse added to the
Scrub Head Lift Actuator circuit.
Replacement Fuse p/n 1016039

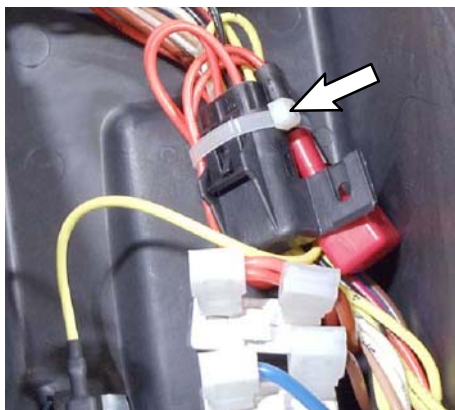
Use a zip-tie to secure the 7.5
Amp Fuse as shown.
